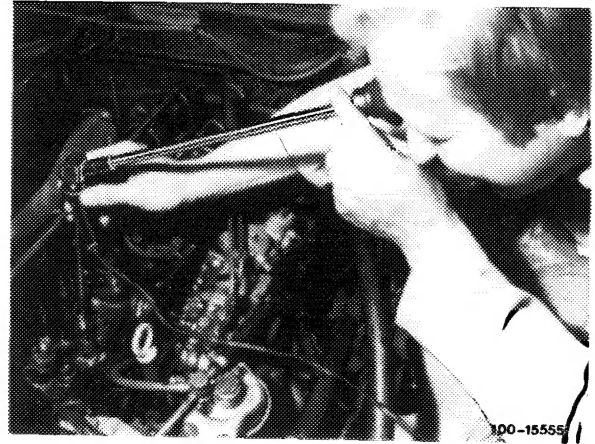
Workshops often find it difficult to assess whether a scored or streaky cylinder liner is so seriously damaged that the engine needs removing or repairing or whether the marks are insignificant. The following notes are intended to help you make a correct, professional decision.

First examine cylinder liner marks to distinguish between "optical streaks" and "seizing marks". "Optical streaks" are normally up to 3 mm wide. They are due to the ring gap but still show signs of honing. In contrast, "seizing marks" make the honing traces disappear completely.

"Streaks at the land side" (in the direction of the piston pin) cannot be due to piston skirt slurring or seizing because there are no points of contact between the piston skirt and cylinder liner.
